INDOOR AIR QUALITY ASSESSMENT

**John M. Tobin School
197 Vassal Lane
Cambridge, Massachusetts**

Prepared by:
Massachusetts Department of Public Health
Bureau of Environmental Health Assessment
Emergency Response/Indoor Air Quality Program
February 2004

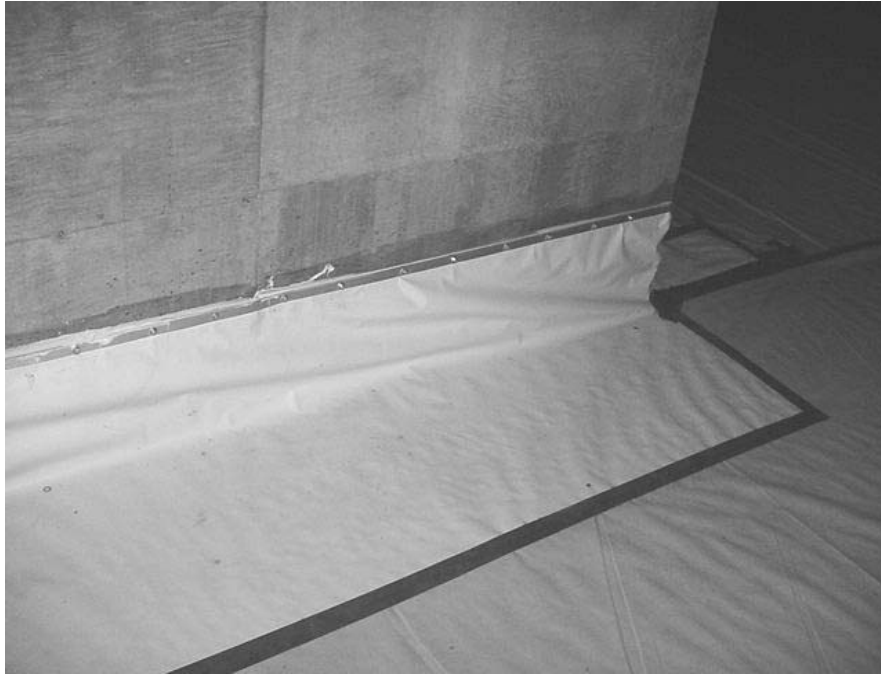
Picture 1

Crawlspace Impermeable Membrane Barrier

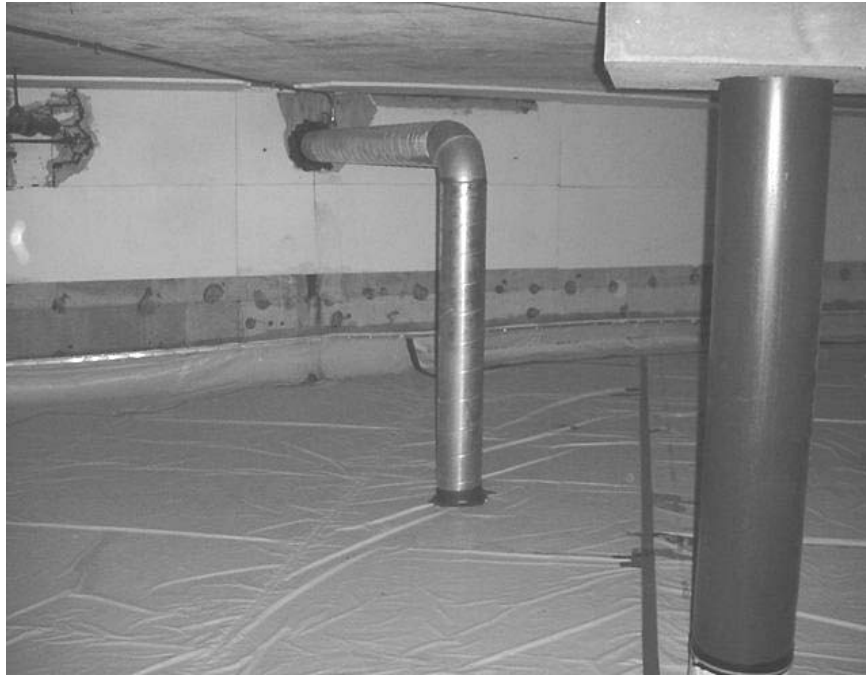
Picture 2

Component Crawlspace Sub-Slab Ventilation System

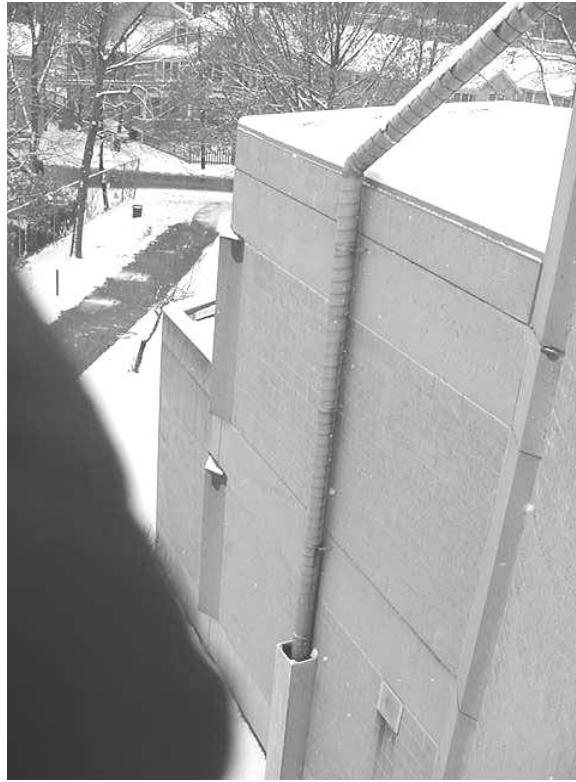
Picture 3

Duct to Roof That Is a Component Crawlspace Sub-Slab Ventilation System

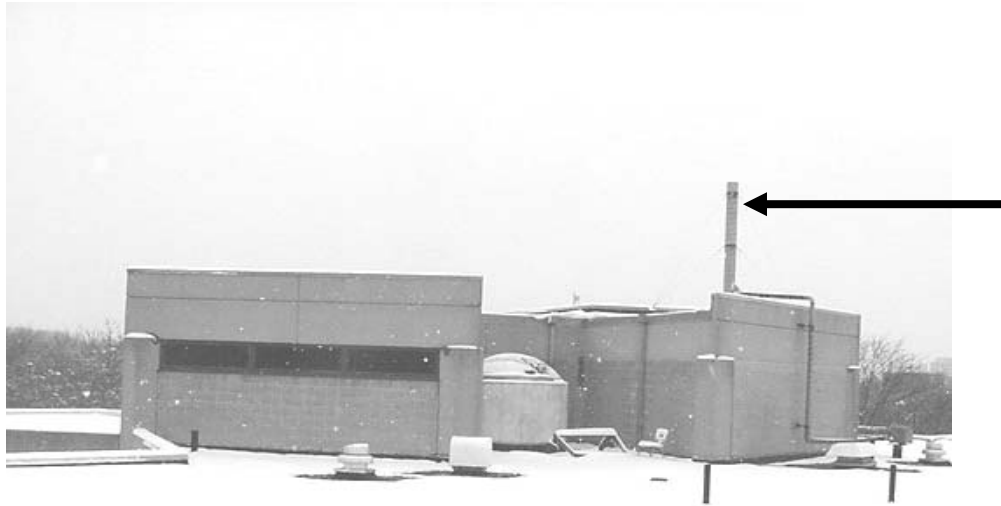
Picture 4

An Exhaust Stack for the Crawlspace Sub-Slab Ventilation System

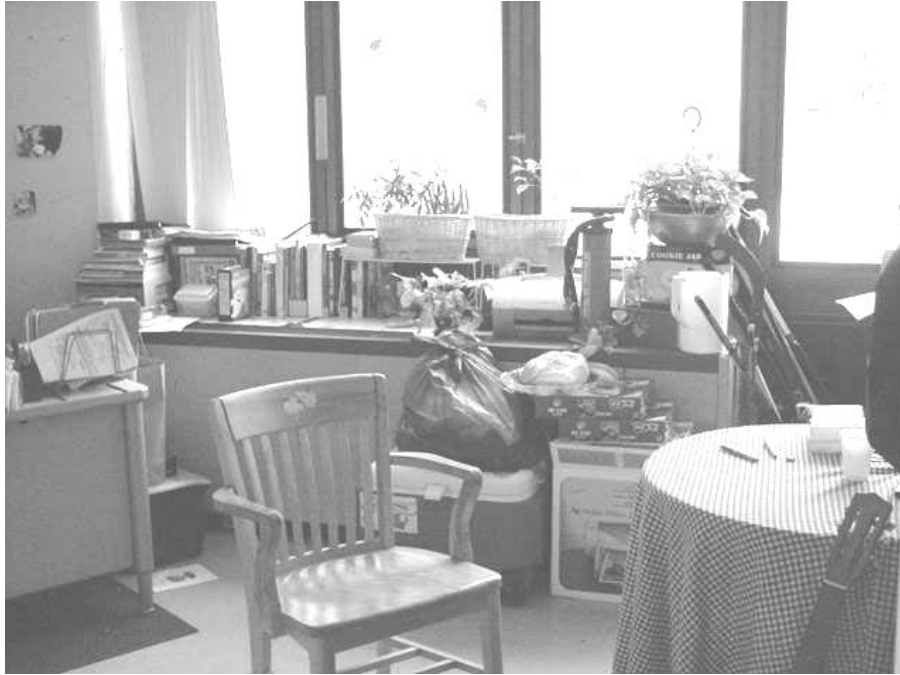
Picture 5

diffuser located in the top of the unit. Obstructions to airflow, such as papers and books stored on top of univents and bookcases and carts and desks placed in front of univent returns, were seen in a number of classrooms (Picture 5). Univents were found deactivated in some classrooms. In order for univents to provide fresh air as designed, intakes must remain free of obstructions. More importantly, these units must remain activated and allowed to operate while these rooms are occupied.

Plants and Other Items on And In Front Of Classroom Univent

3. Inspect exhaust motors and belts periodically for proper function. Repair and replace as necessary.
4. Remove all blockages from univents and exhaust vents to ensure adequate airflow.
5. Consult a ventilation engineer concerning re-balancing of the ventilation systems.

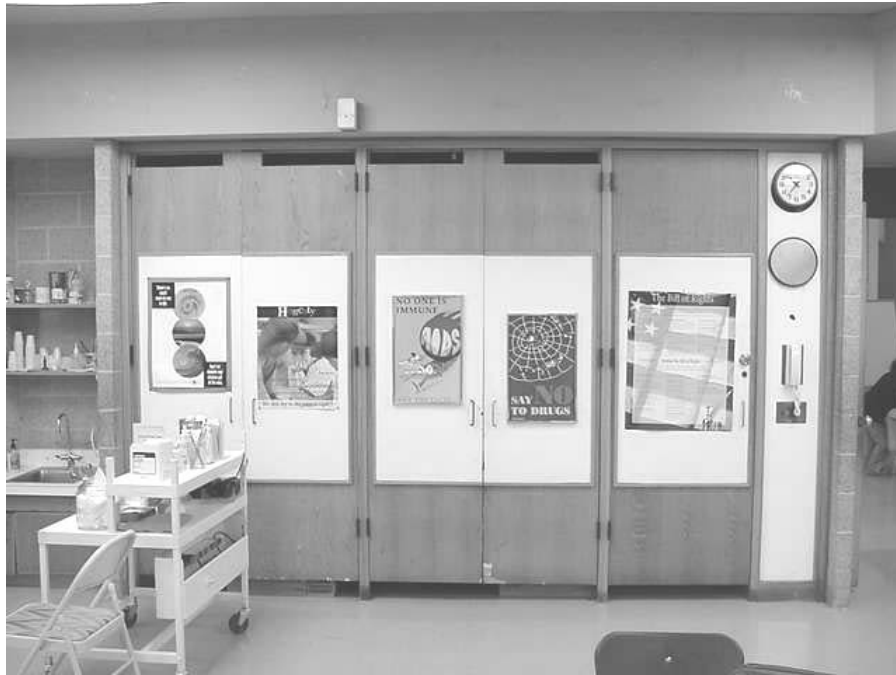
Picture 6

Undercut Classroom Coat Closets Containing Exhaust Vents

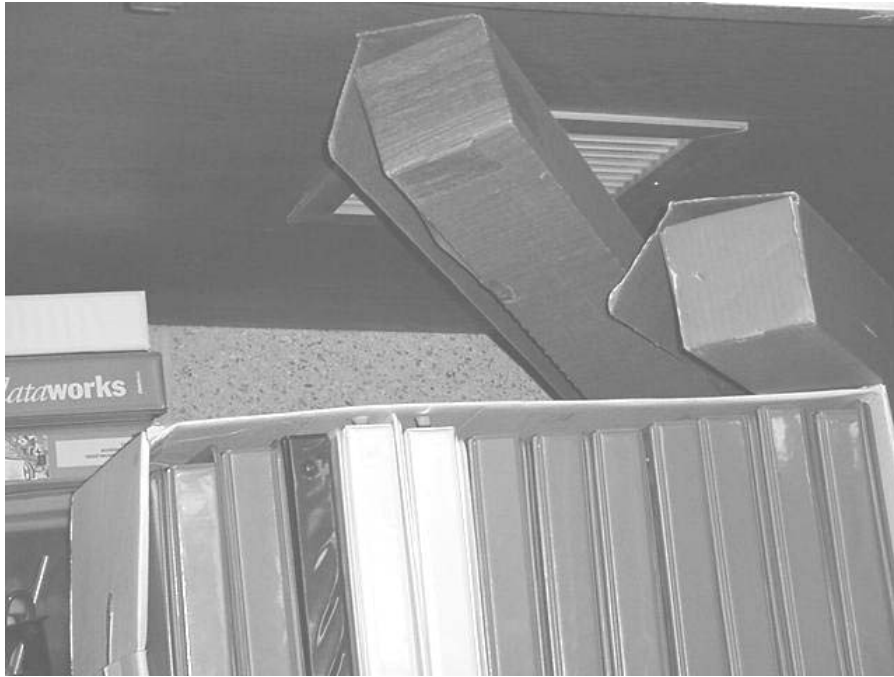
Picture 7

Classroom Exhaust Vent in Coat Closet Obstructed by Stored Items

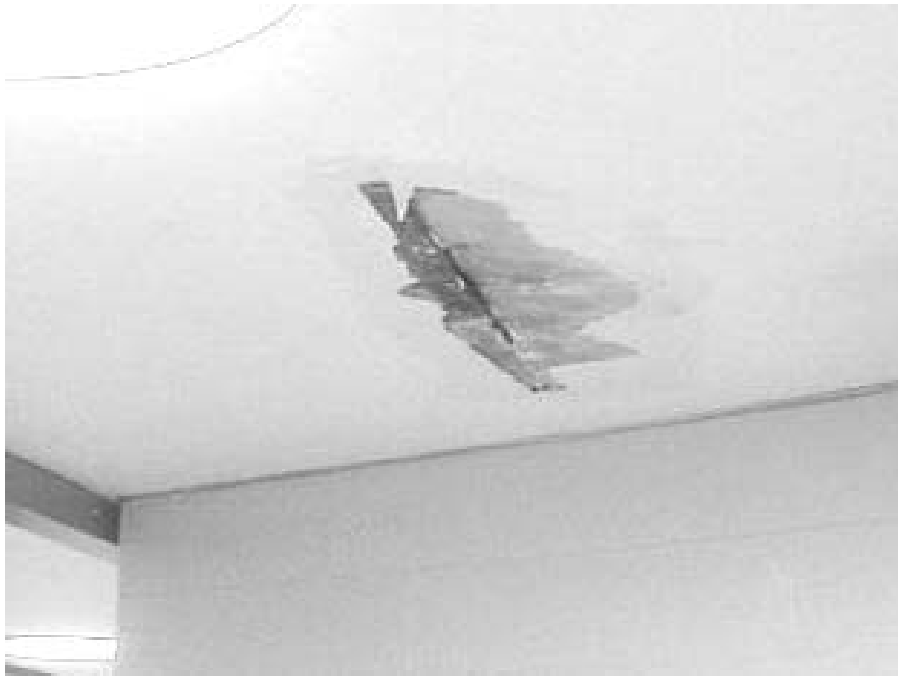
Picture 8

The building has a history of water penetration problems. A number of areas had water-damage and stained building materials (e.g., walls or ceilings), which can indicate leaks from the roof or plumbing system (Picture 8). Active roof leaks were reported in hallway areas outside of classrooms 306 and 308. Buckets were stationed throughout the hallway to catch dripping rainwater (Picture 9). Water-damaged porous building materials can provide a source for mold and should be replaced after a water leak is discovered.

Water-Damage and Stained Building Materials

Disinfect areas of water leaks with an appropriate antimicrobial. Clean areas of antimicrobial application when dry.
9. Move plants away from univents in classrooms. Avoid over-watering and examine drip pans periodically for mold growth. Disinfect with an appropriate antimicrobial where necessary.
10. Seal areas around sinks to prevent water-damage to the interior of cabinets and adjacent wallboard. Inspect adjacent areas for water-damage and mold/mildew growth,

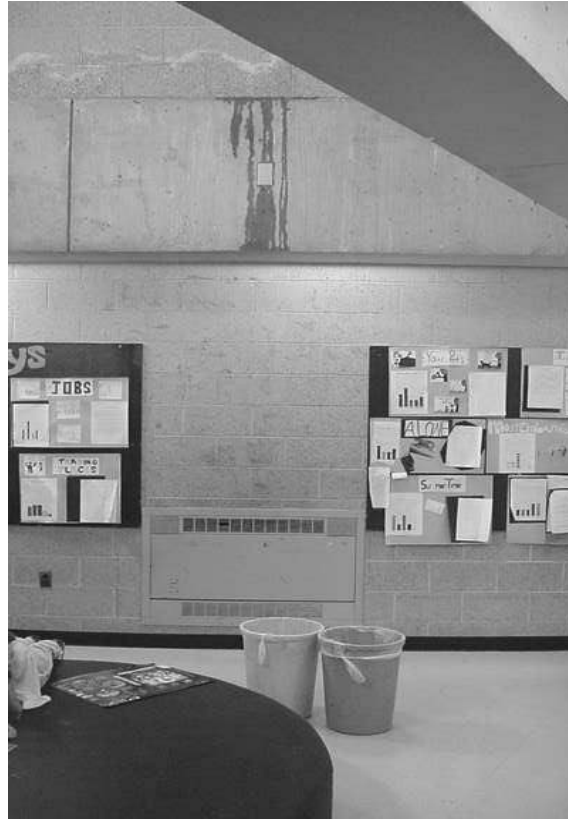
Picture 9

Buckets Were Stationed Throughout the Hallway to Catch Dripping Rainwater

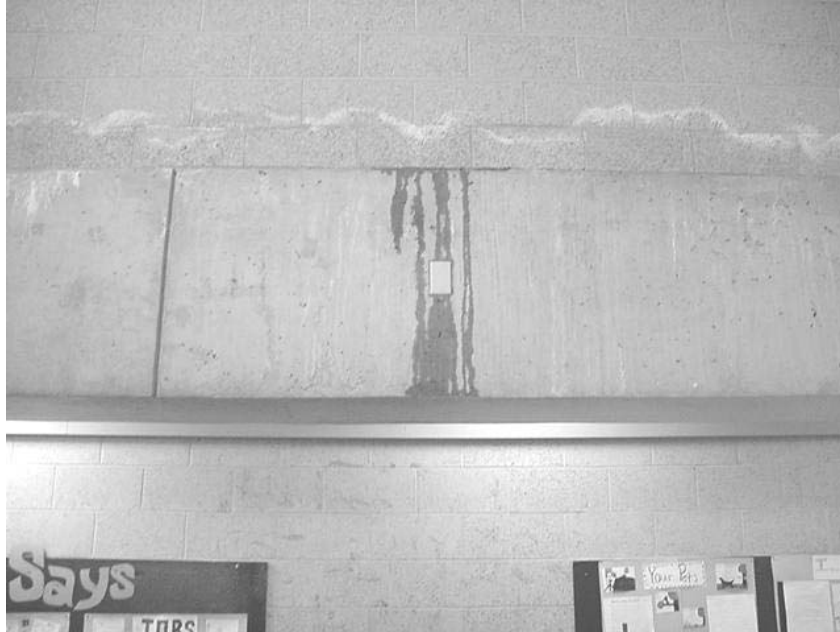
Picture 10

Efflorescence (e.g., mineral deposits) was observed in a number of classrooms (Pictures 10 through 13). Efflorescence is a characteristic sign of water damage that appears on building materials such as brick or plaster, but it is not mold growth. As moisture penetrates and works its way through mortar and brick, water-soluble compounds dissolve, creating a solution. As the solution moves to the surface of the brick or mortar, water evaporates, leaving behind white, powdery mineral deposits. This condition indicates that water from the exterior has penetrated into the building.

Efflorescence on Hallway Wall

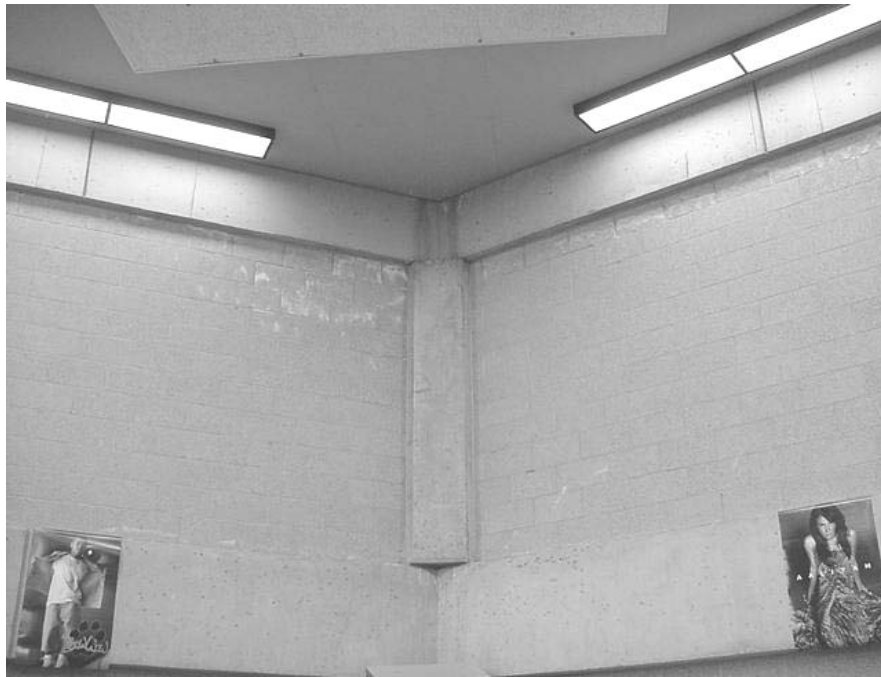
Picture 11

Efflorescence on Music Room Walls around Cement Beams

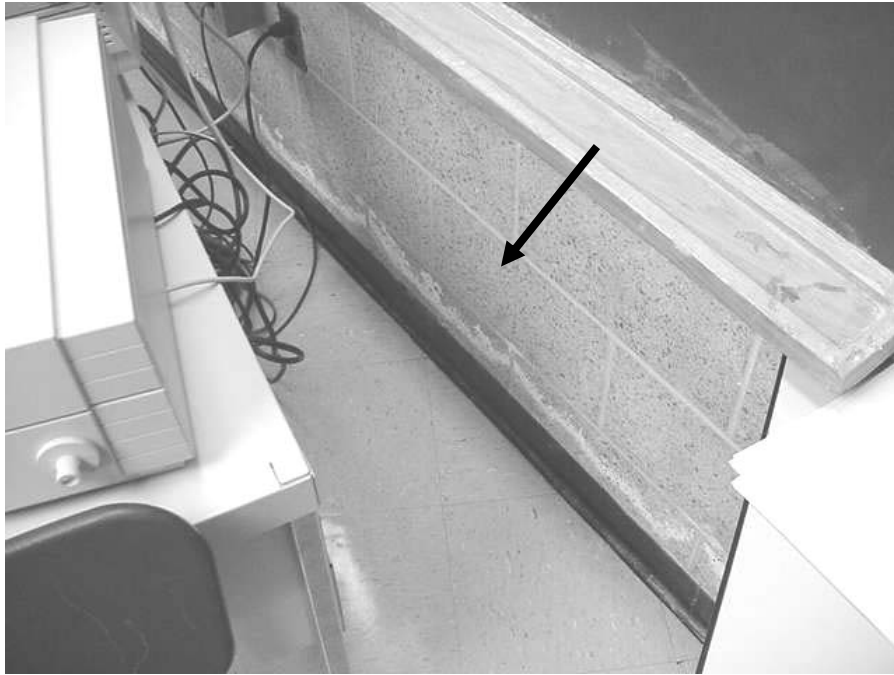
Picture 12

Efflorescence on Wall of Classroom

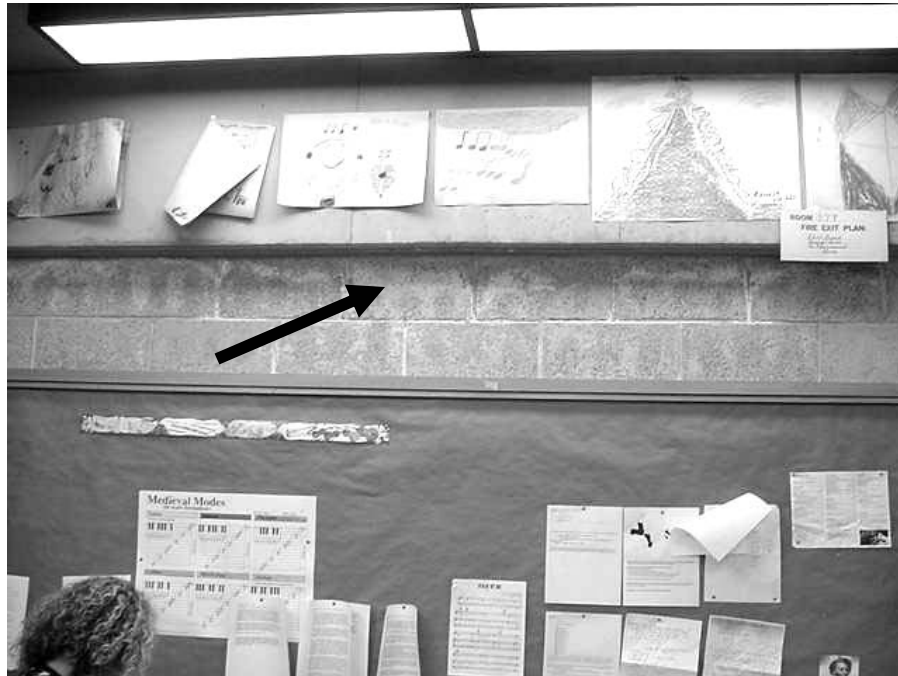
Picture 13

Efflorescence on Wall of Classroom

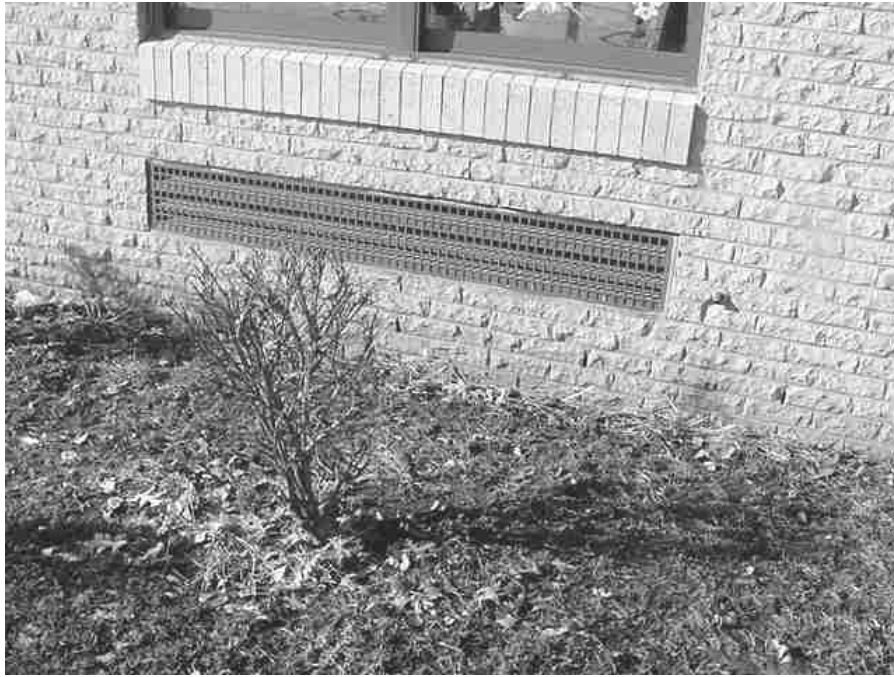
Picture 14

An Example of a Typical Univent Fresh Air Intake with Louver Vents Installed Parallel to the Ground (Murkland Elementary School, Lowell, MA)

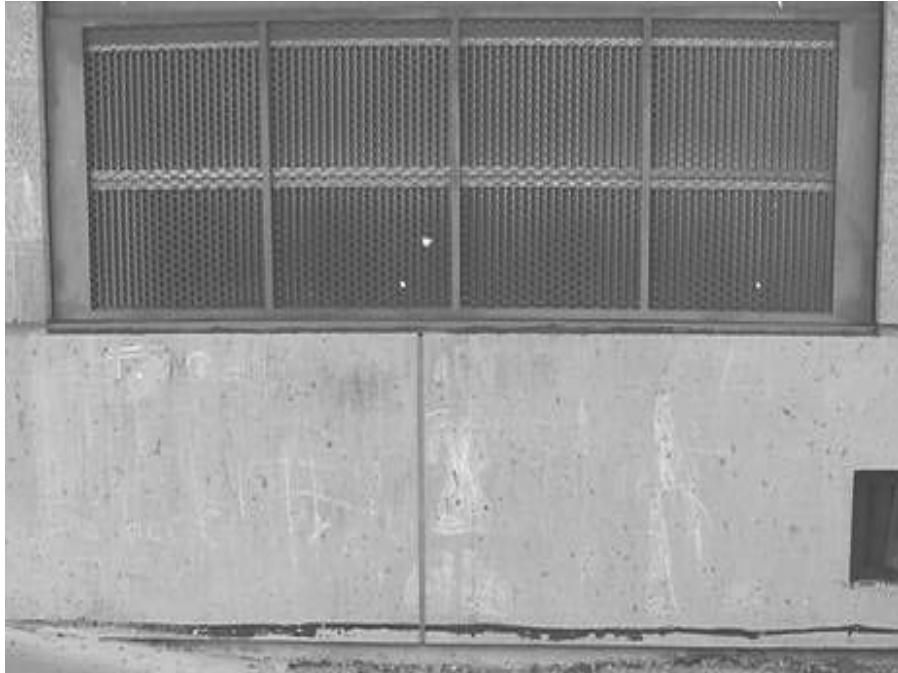
Picture 15

Exterior Univent Fresh Intake Grille Installed With Louvers Perpendicular to the Ground

1. Examine the feasibility of replacing UFAs with vertical louvers with properly pitched grilles.
2. Repair/replace seams between pilasters and concrete support beams in the exterior wall blocks. Consider installing flashing in these seams.
3. Repair/replace missing or damaged window caulking and gaskets building-wide to prevent water penetration through window frames. Examine all water-damaged materials for microbial growth and structural integrity. Repair water damaged ceilings, walls and wall-plaster as necessary.
4. Consider installing ceiling-mounted univents or alternate air handling equipment in ground floor classrooms and the cafeteria to prevent flooding during heavy rain.

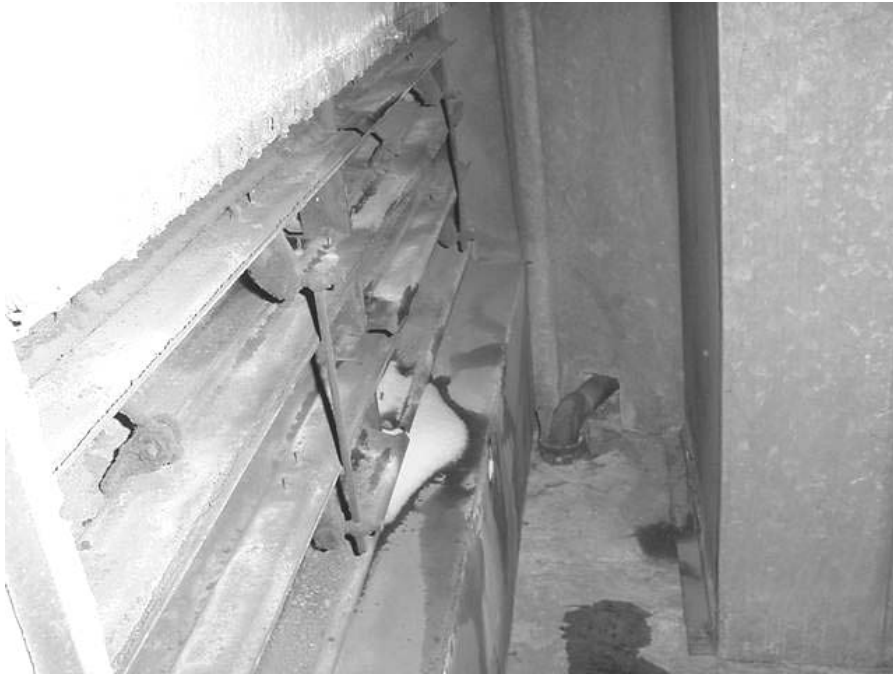
Picture 16

Snow on Air Intake Louvers Inside Gymnasium AHU

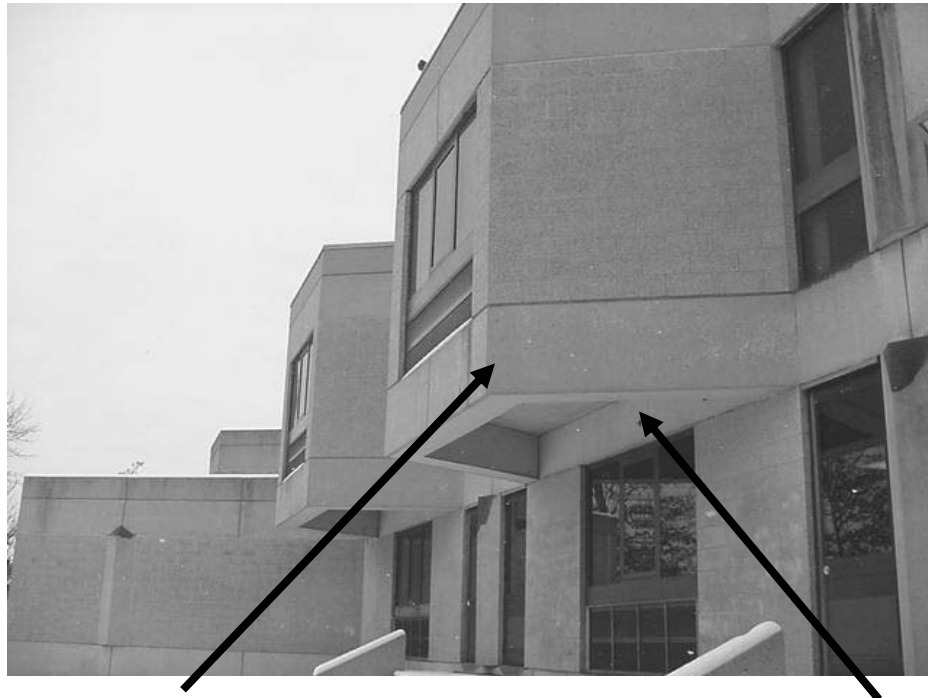
Picture 17

Upper Floor Classroom with Cantilever Overhang

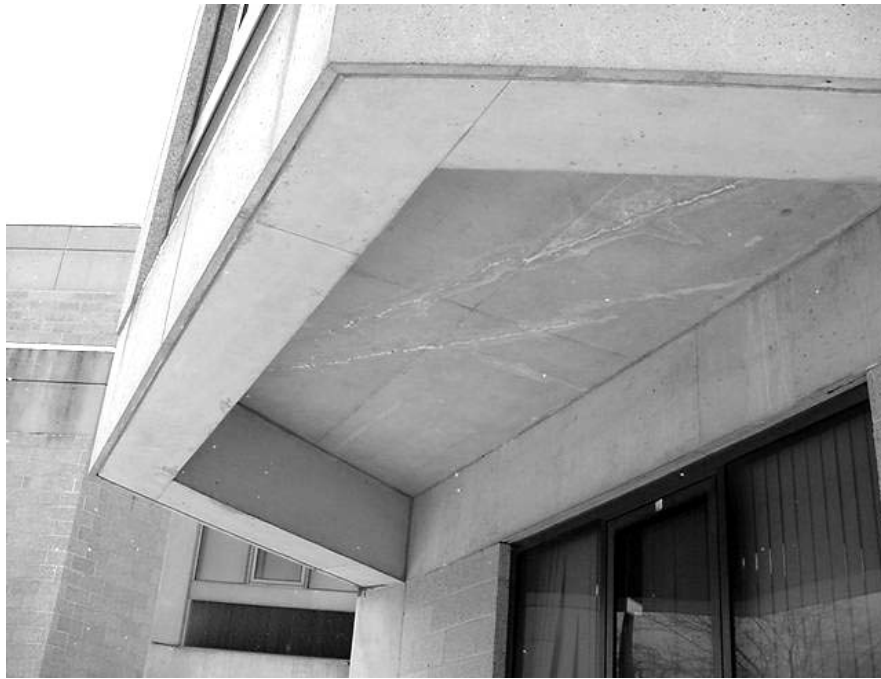
Picture 18

Example of Cracking and Efflorescence in Cement beneath and Behind UFAI

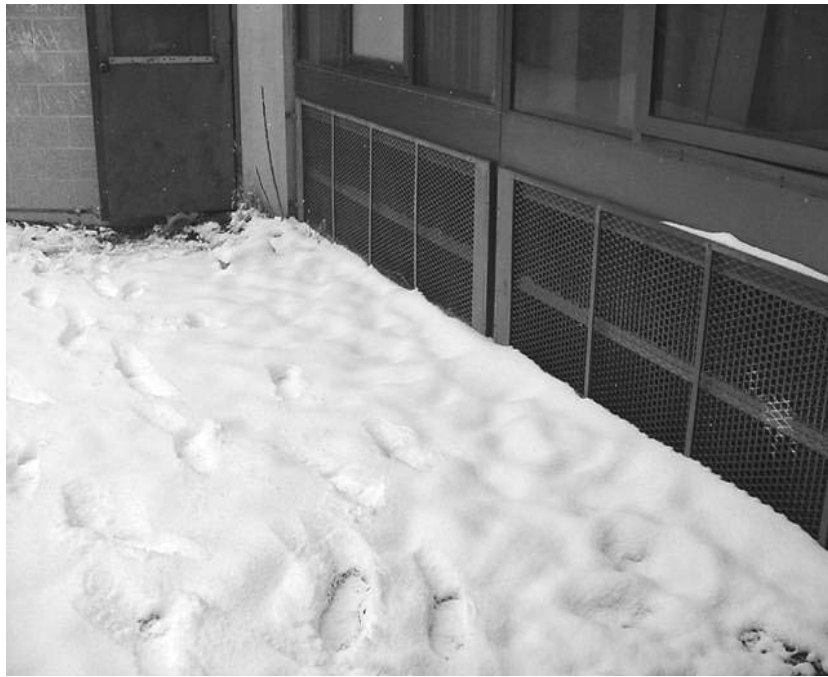
Picture 19

2. UFAI location and water drainage: The ground floor of the TS is located below ground level. A cafeteria and a number of classrooms are located on the ground floor. UFAIs were installed near ground level in these areas (Picture 19). Of particular note are the cafeteria UFAIs, located at the bottom of a slope (Picture 20). According to building personnel, the cafeteria has flooded during downpours as a result of water entry through the UFAIs. Flooding is the result of improper drainage in areas in front of UFAIs. Improper drainage was also witnessed in front of classroom areas. Crushed stone is used to fill areas adjacent to classrooms, which are located at the front of the building. Storm drains are also installed in these areas. Over time the stones around the drain have settled. The drains are now the highest point in the aforementioned areas, thus impeding proper drainage. Improper drainage causes pooling of water, as noted in an area outside a sub-level classroom.

Classroom UFAls Installed Near Ground Level

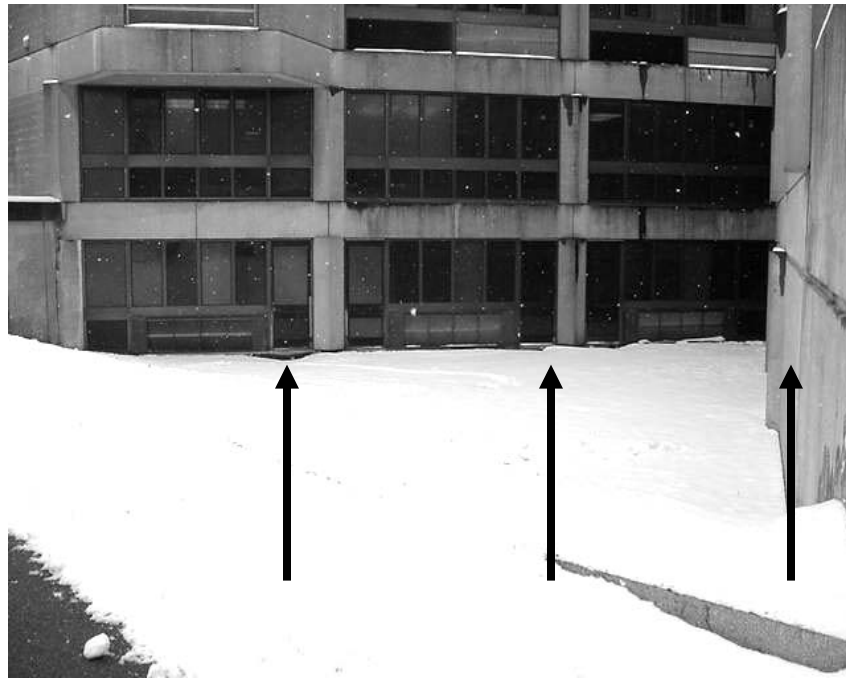
Picture 20

Cafeteria UFAs Installed Near Ground Level at Bottom of Slope

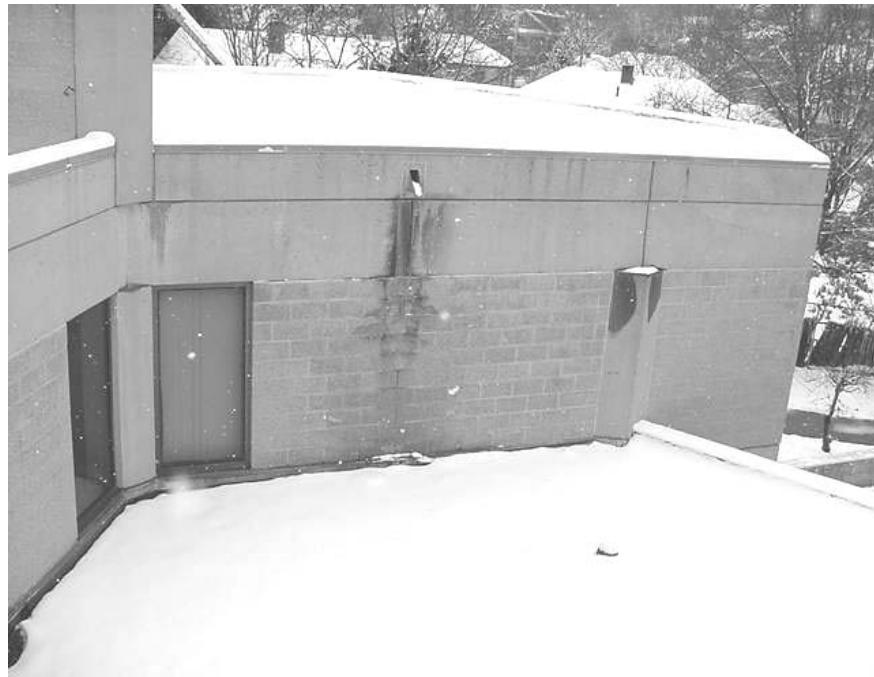
Picture 21

Lower Roofs That Are Joined To an Exterior Wall of the Building

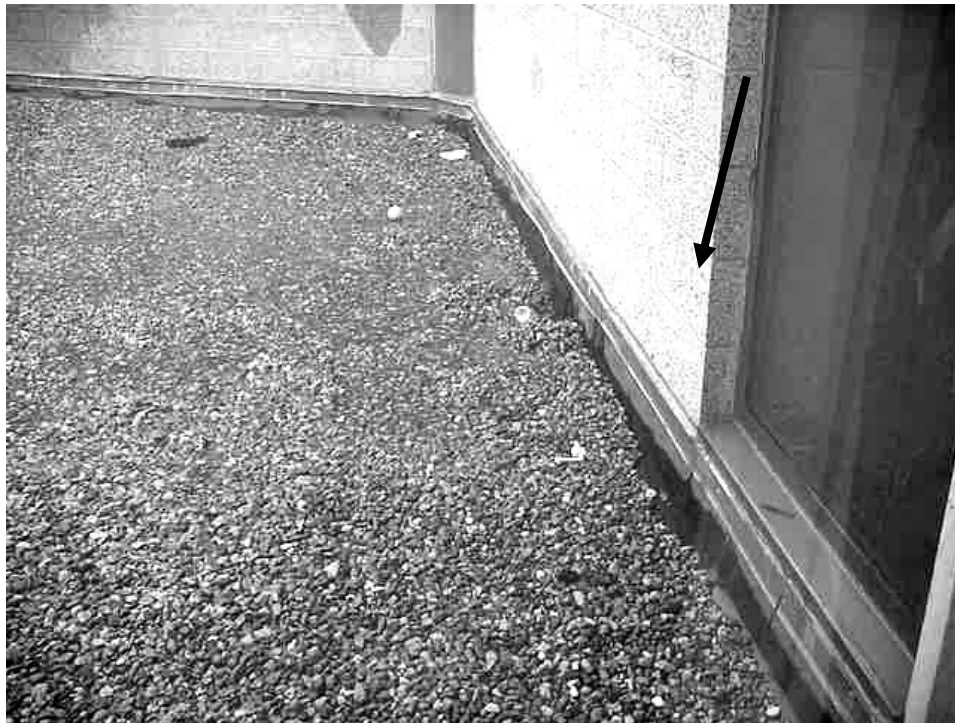
Picture 22

Lower Roof Drain Installed at Roof/Wall Junction

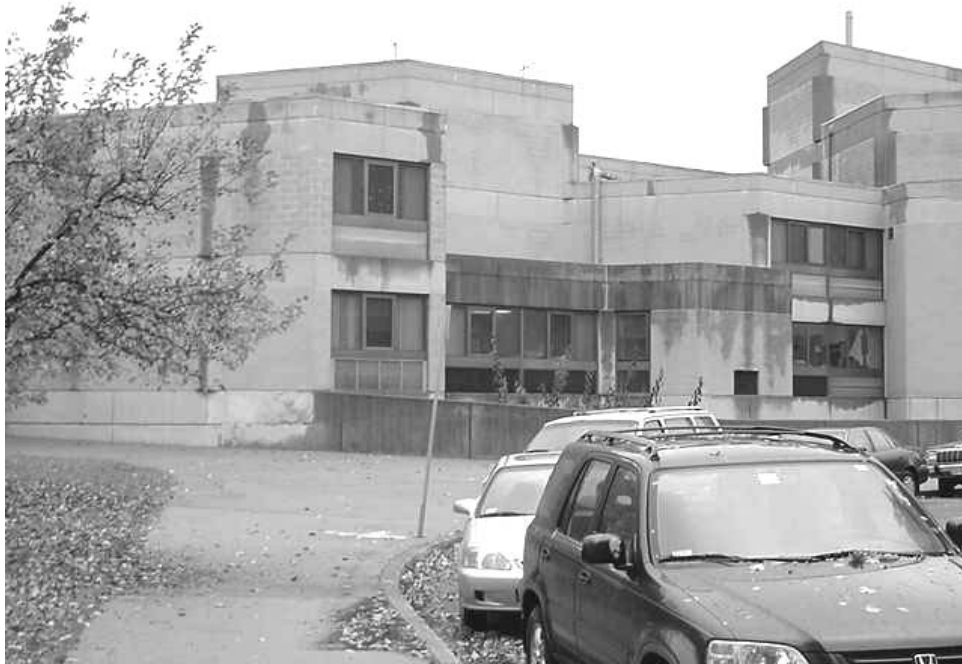
Picture 23

Water Spilling off Edge of Roof, Note Dryness of Surrounding Walls

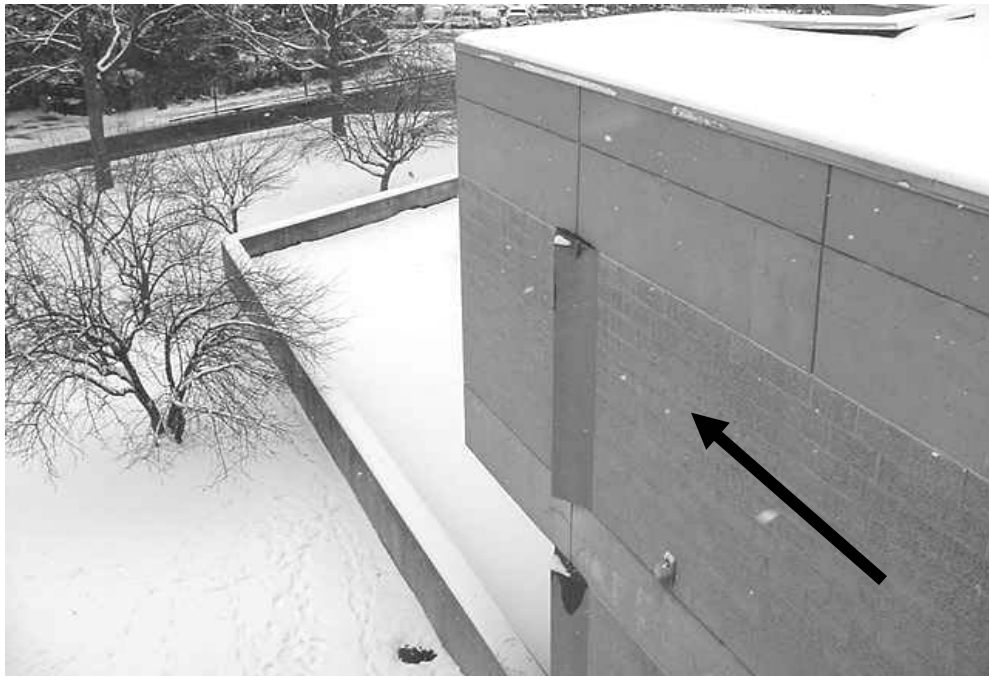
Picture 24

A Pilaster Built Into the Exterior Wall, Note Moistened Top

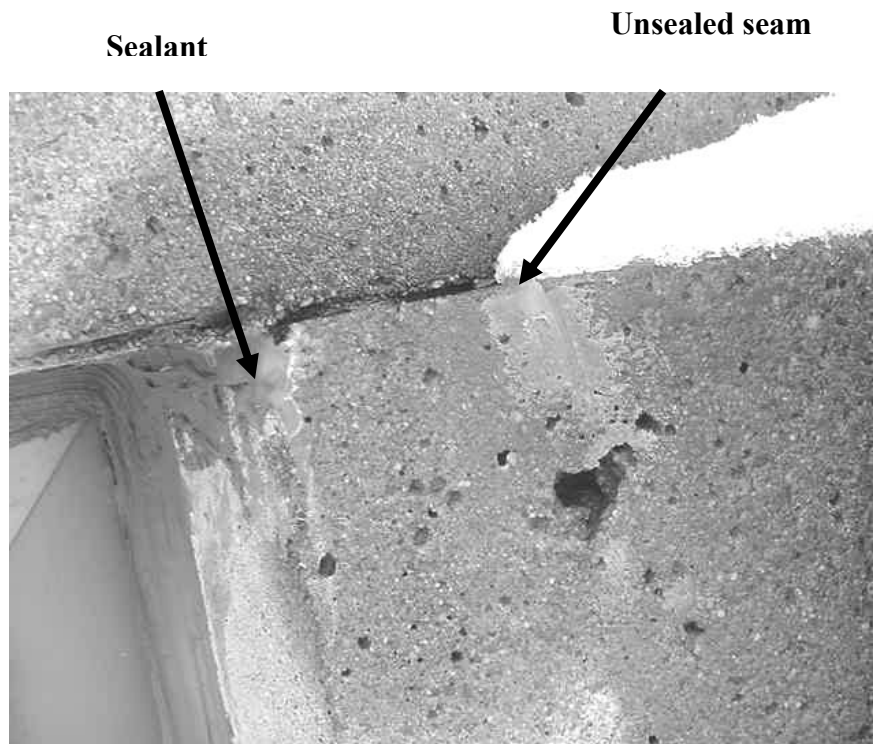
Picture 25

and the exterior brick. Instead, these seams are sealed with a caulking compound (Picture 25). Over time, caulking has been weathered. Degraded seals or open seams can allow for water penetration.

Pilaster with Cement on Top, Note Unsealed Seam and Accumulated Snow On Pilaster Top

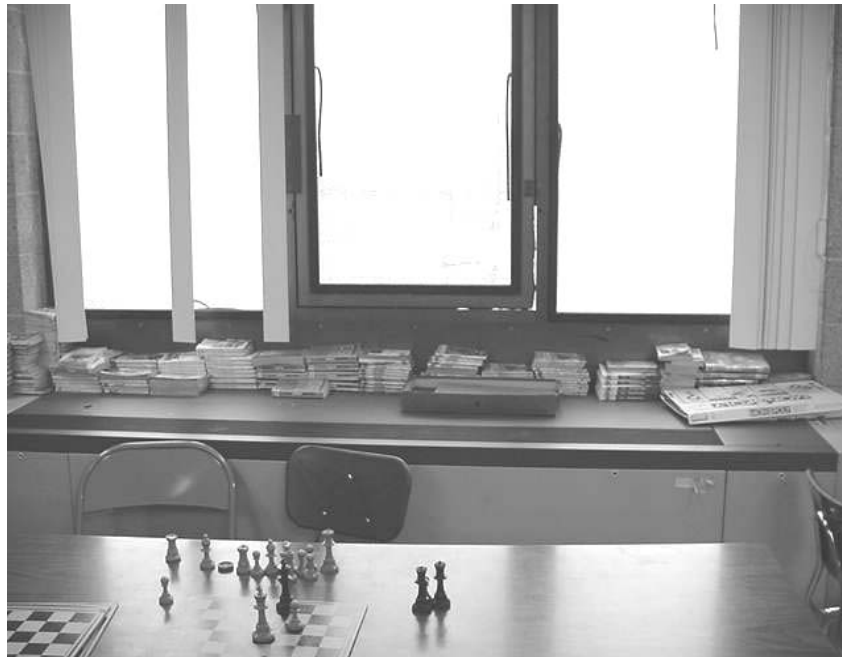
Picture 26

6. Window frame damage: Gaskets around openable windows were worn or missing (Picture 26). Caulking around windowpanes and frames was also worn, damaged or missing (Picture 27). During the November 6, 2002 visit, BEHA staff noted that cat litter was used to absorb rainwater chronically penetrating through the window frame in one classroom (Picture 28). Seams created by damaged or missing window frame materials are sources for water penetration.

Window with Worn Gasket (Note Outdoor Light Penetrating Between Window And Frame)

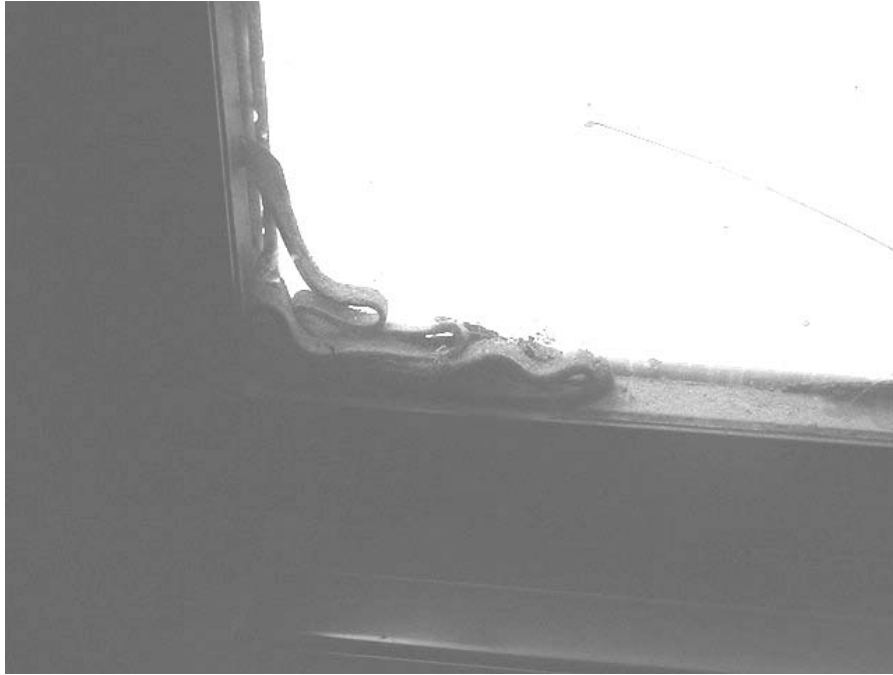
Picture 27

Missing/Damaged Window Caulking in Classroom

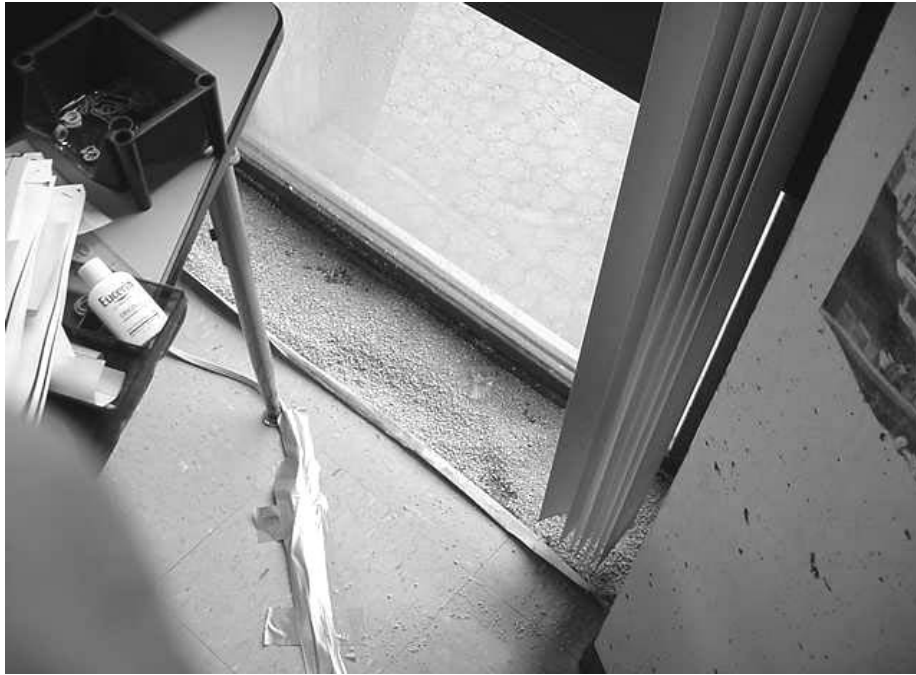
Picture 28

Cat Litter Spread at Base of Window Frame to Absorb Rainwater

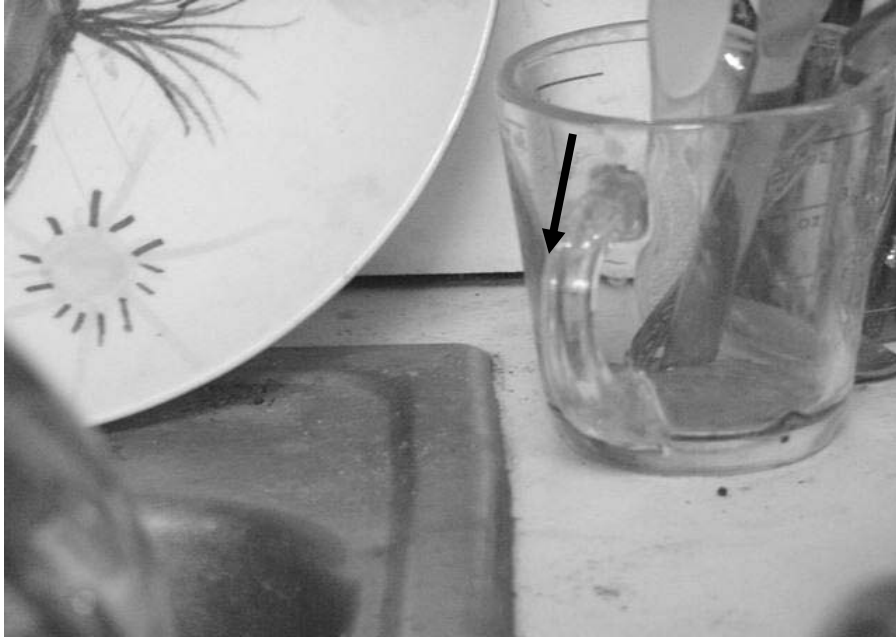
Picture 29

Several classrooms have sinks that had an open seam between the countertop and backsplash (Picture 29). Improper drainage or sink overflow could lead to water penetration of countertop wood, the cabinet interior and behind cabinets. Like other porous materials, repeated wetting of these materials can be conducive to mold growth.

Open Seam between Sink Countertop and Backsplash

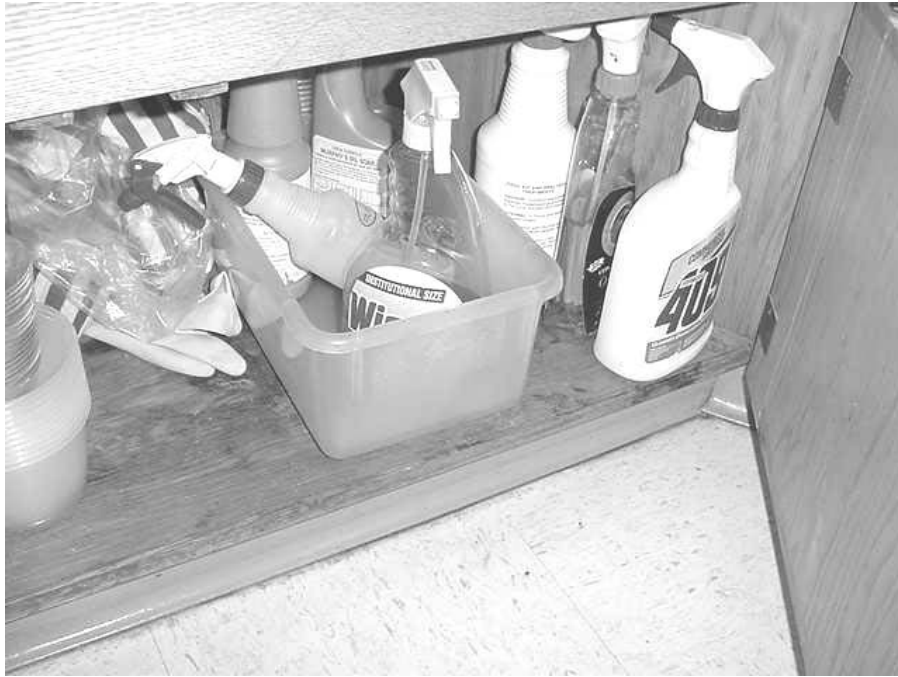
Picture 30

Several other conditions that can potentially affect indoor air quality were identified. Spray cleaning products were found on countertops and in unlocked storage cabinets beneath sinks in classrooms (Picture 30). Cleaning products contain chemicals that can be irritating to the eyes, nose and throat. Cleaning products should be stored properly and kept out of reach of students.

Spray Cleaning Products in Unlocked Cabinet beneath Classroom Sink

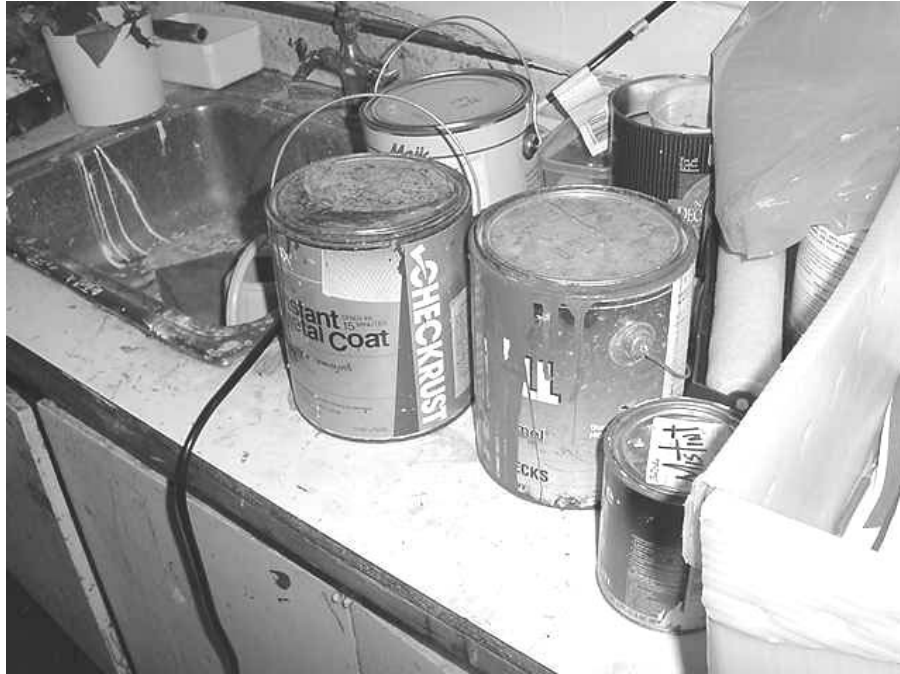
Picture 31

Also noted on a tabletop were several cans of wood sealant and paint, which were not properly sealed (Picture 31). These products contain VOCs, which evaporate readily and can be irritating to eyes, nose and throat. Additionally, these products are flammable and should be stored in a cabinet that meets the criteria set forth by the National Fire Protection Association (NFPA) (NFPA, 1996).

Improperly Stored/Sealed Paints and Sealants on Classroom Countertop

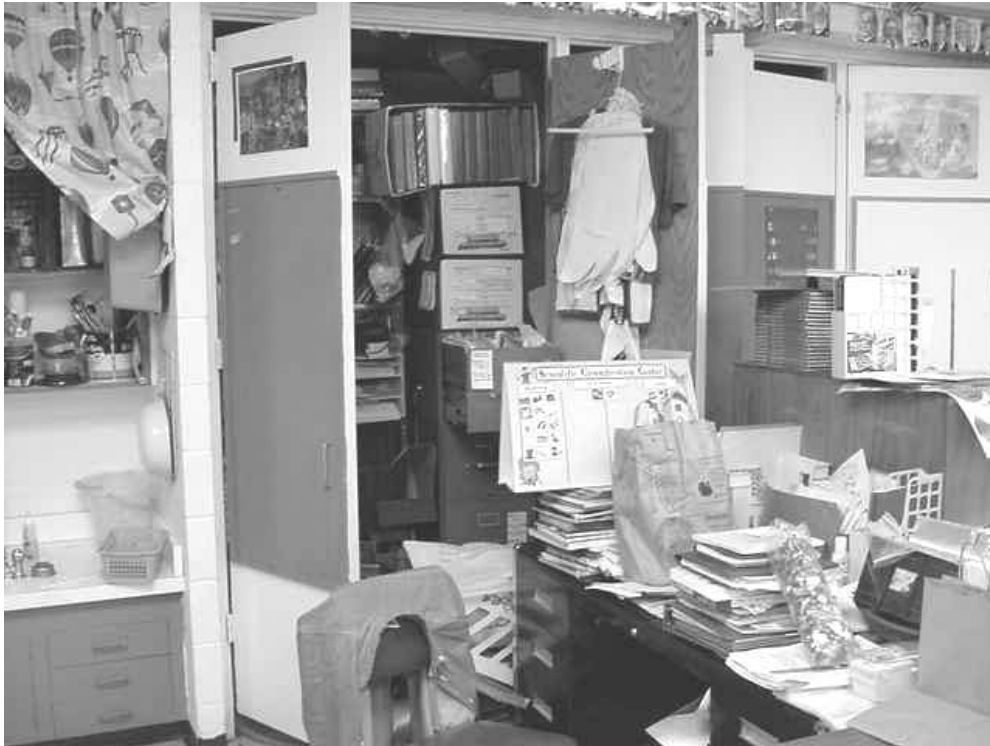
Picture 32

Also of note was the amount of materials stored inside classrooms. In classrooms throughout the school, items were observed to be on windowsills, tabletops, counters, bookcases and desks (Picture 32). The large number of items stored in classrooms provides a source for dust to accumulate. These items (e.g., papers, folders, boxes) make it difficult for custodial staff to clean. Dust can be irritating to eyes, nose and respiratory tract. Items should be relocated and/or be cleaned periodically to avoid excessive dust build up.

Accumulated Items Stored in Classroom
